AFFTC-TR-76-11 ✓

FLIGHT PLANNING AND CONDUCT OF THE X-24B RESEARCH AIRCRAFT FLIGHT TEST PROGRAM

JOHNNY G. ARMSTRONG
X-24B Project Manager

December 1977
Final Report

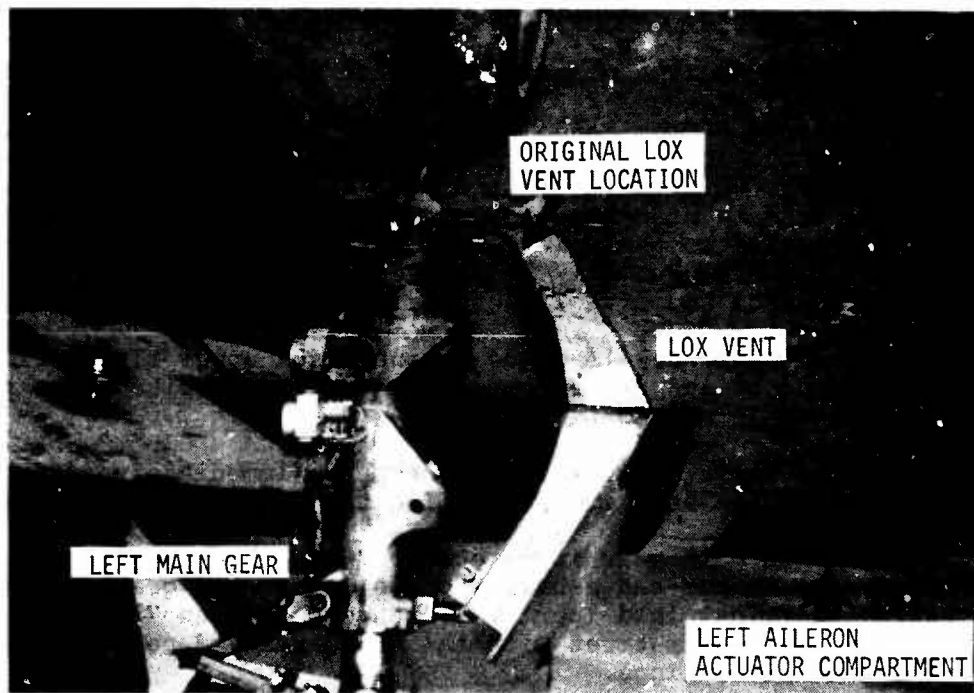
FIGURE 36 X-24B LOX VENT

During mated flight to the launch point the LOX lost from the X-24B due to "boil-off" was replenished (topped-off) from LOX tanks located in the bomb bay of the NB-52B. As the X-24B tank became full, the overflow of LOX exited the tank thru a LOX vent line located on the bottom of the aircraft. When the aircraft was delivered the LOX vent outlet was located just forward of the left hand main landing gear compartment. With the knowledge that a similar location on one of the lifting bodies had caused a slow gear extension due to the low temperature of LOX venting over the gear compartment, an ad hoc committee, independently reviewing the flight readiness for the first powered flight, recommended that the LOX vent be relocated. The vent was moved outboard away from the gear well but upstream of the aileron compartment (Figure 36). Reference 1 presents the details of the sequence of events in attempting to identify the cause of the aileron deadband, which included replacement of components, instrumenting the aileron linkage and compartment temperature, and environmental ground tests of components. With the results for the above checks it was confirmed that the aileron deadband was caused by excessively low temperature of the hydraulic system components resulting from the LOX vent overflow. Figure 37 presents a summary of the time that the skin temperature of the aileron compartment was colder than -100 degrees F (limit of measurement) as a result of LOX (~-300 degrees F) flowing over the area during top-off. During powered flights thru flight eleven, a single top-off of approximately 30 to 35 minutes duration was used. For flights 12 through 17, two short duration top-off cycles were used with a corresponding reduction in cold soak time and without the occurrence of the aileron deadband. On flights 18 and 19 the initial top-off cycle was again too long resulting in excessive cold-soak and aileron deadband. After flight 19 the top-off procedure was changed to include three top-off periods of short duration with each top-off cycle being terminated when the LOX vent temperature indicated liquid LOX was exiting the vent. With this procedural change the aileron deadband never reoccurred. However the real lesson here is not the importance of proper top-off procedures but rather that careful consideration must be given to the location of LOX vent lines during design.

LOX venting from a location forward of the left aileron compartment resulted in a cool-down of the aileron actuator components that caused an undesirable aileron deadband on some flights.
